MÁRVÁNY DERÉKSZÖGŰ CSATLAKOZÁSOK MECHANIKAI VISELKEDÉSÉNEK VIZSGÁLATA INNOVATÍV KÍSÉRLETI TECHNIKÁKKAL
THE MECHANICAL RESPONSE OF MARBLE EPISTYLES STUDIED WITH THE AID OF INNOVATIVE EXPERIMENTAL TECHNIQUES

KOURKOULIS^{1,*}, S. K., PASIOU¹ E. D., I. STAVRAKAS², HLOUPIS² G., TRIANTIS² D.

Kulcsszavak: márvány, csatlakozások, tradicionális és innovatív kísérleti technikák
Keywords: marble, epistyles, traditional and innovative techniques

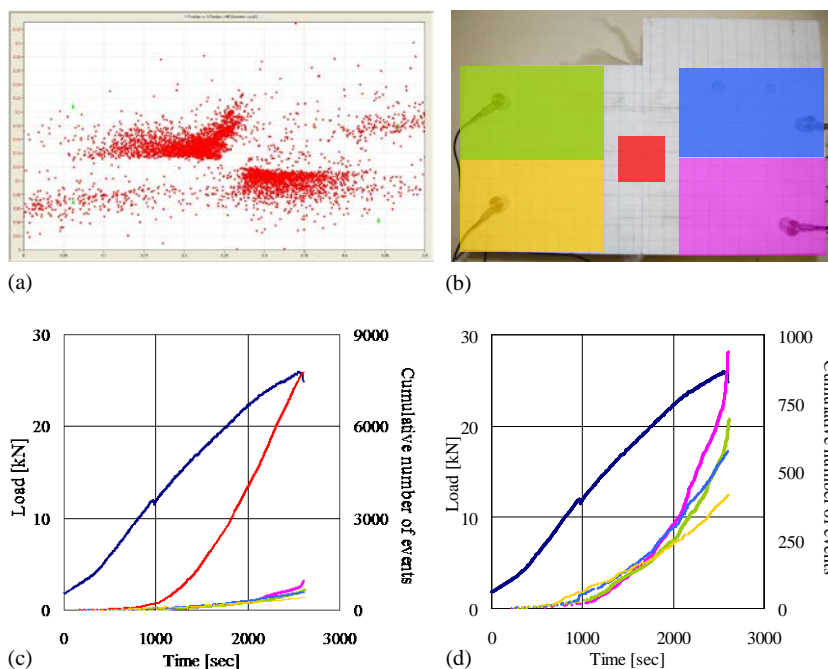
Figure 7: (a) The two dimensional distribution of the acoustic events.
(b) The five regions of the specimen in which the acoustic events were quantified.
(c) The cumulative number of acoustic events as detected in the five regions of the specimen and the load imposed vs. time.
(d) The cumulative number of acoustic events as detected in the four regions around the flanges of the

groove and the load imposed vs. time. It is clearly seen that the rate of the acoustic events produced in the region where the final fracture takes place becomes larger than the ones of the other three regions well before the crack appears.

area increase while additional events are also detected around the “heads” of the groove (Fig.7a). For an optimum representation of the acoustic events’ location to be achieved, the specimen was divided in five parts as it is shown in Fig.7b. The cumulative number of events is plotted in Fig.7c, for each one of all five regions of Fig.7b, in juxtaposition to the respective variation of the force induced by the loading frame. To gain better insight of the cumulative number of events in the four regions surrounding the central one (which are shadowed by the number of events in the central portion of the specimen) they are plotted again in Fig.7d, without the respective variation at the central region. Well before the final fracture, the cumulative number of events at the lower part of

the right epistyle starts exceeding the events at the other three parts. It is noticed that the number of events in all five regions becomes measurable only after the first load- (and PSC-) drop and then their number starts increasing abruptly until the final fracture of the moving block. It is very interesting to observe that as the fracture load level is approached the cumulative number of events at the lower part of the right epistyle (the area where the final catastrophic crack will appear) starts increasing at a higher rate exceeding significantly the events recorded at the other three parts. Moreover it is to be highlighted that the above change of the events accumulation rate at the region of final crack appearance is designated also by the slope-change of the load-displacement curve.

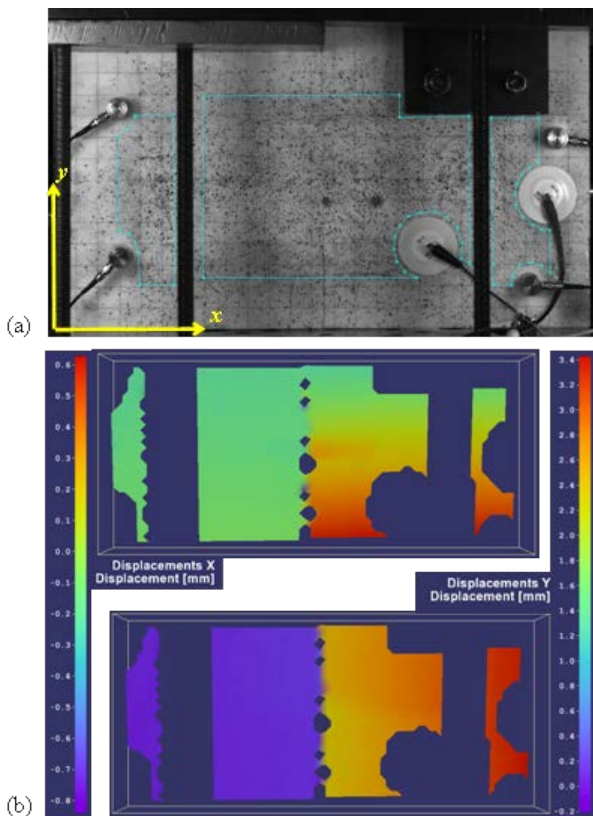
Figure 8: (a) A typical photo as captured by the cameras of the DIC technique.
(b) The distribution of the x- and y-component of the displacement field developed in the front surface of the specimen during the last photo captured before the epistyle's fracture.

quantification of parasitic phenomena. In this direction the variation of the displacement field components along the x-axis (the axis of the connector) and y-axis were recorded as functions of time. It was definitely concluded that the right marble block (i.e. the one on which the load is applied) does not behave as a rigid body: Indeed as the load induced increases its right part experiences larger displacement along the y axis while its lower part experiences larger displacement along the x axis. The final distributions of these displacement components can be seen in Fig.8: The development of a parasitic bending moment in the xy-plane is obvious.
